U.S. Army Corps of Engineers'  
Upper Mississippi River Restoration  
Long Term Resource Monitoring Element

**Completion Report**  
LTRMP-2019AER7

## **Changes in aquatic vegetation cover following lock closure on the Illinois Waterway from 2019 – 2021**

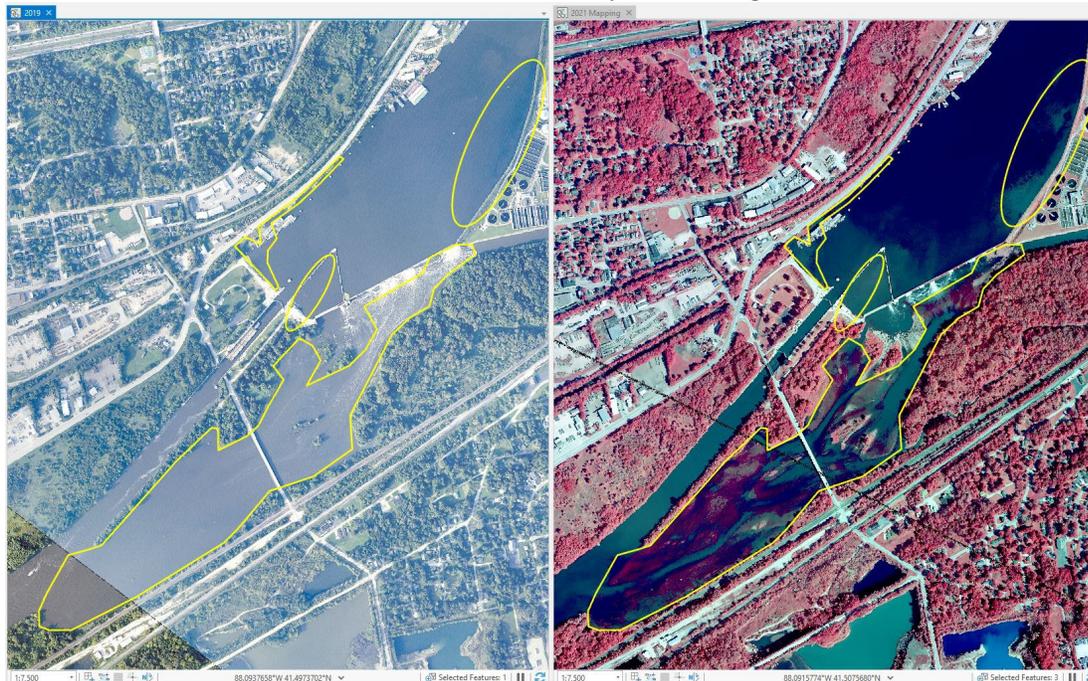
Figure 6. A screen capture comparing the 2019 vegetation (left) to the 2021 vegetation (right) at the Joliet Generating Station in Dresden Pool along the main navigation channel of the Illinois Waterway showing increased SAV over the two years. Area of interest outlined in yellow. Image centered on 41.495°N, 88.118°W.

In figures 4–9, areas of observed vegetation change are primarily adjacent to the main navigation channel of the IWW and are focused submersed aquatic vegetation (SAV). These beds appear to show a general pattern towards increased cover from 2019 to 2021, but some confounding variables warrant consideration. The first is the unavailability of CIR imagery for portions of the 2019 flight in this area. The second is the increased water clarity in the 2021 imagery. The third is the higher water level in the 2019 imagery. These three issues combine to confound a simple, visual appraisal of SAV cover that might determine direction and degree of change in cover.

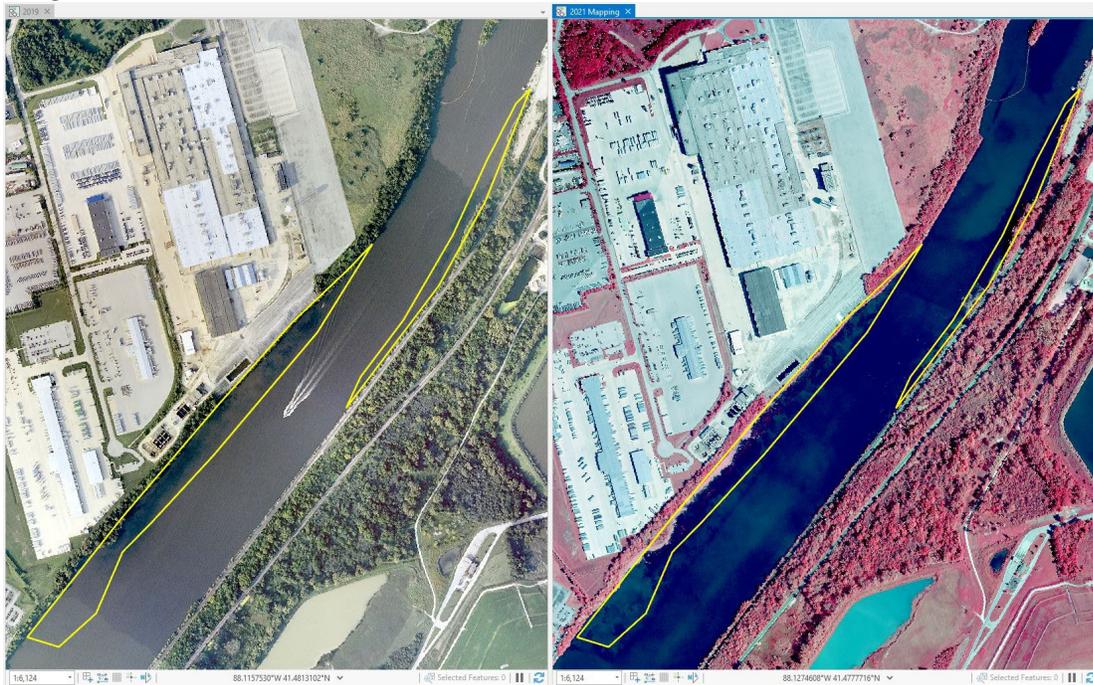
Figure 8. A screen capture comparing the 2019 vegetation (left) to the 2021 vegetation (right) at Houbolt Road extension in Dresden Pool along the main navigation channel of the Illinois Waterway showing increased submersed and emergent aquatic vegetation cover over the two years. Area of interest outlined in yellow. Image centered on 41.468°N, 88.160°W.

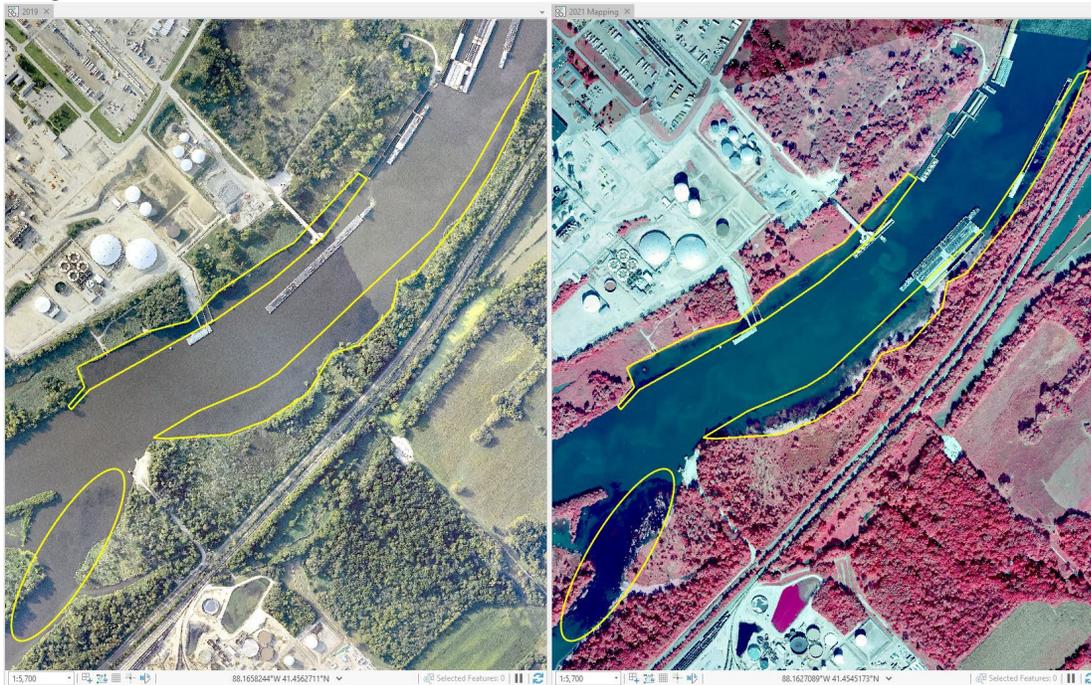
Figure 10. A screen capture comparing the 2019 vegetation (left) to the 2021 vegetation (right) at Du Page River mouth bay, north, in Dresden Pool along the main navigation channel of the Illinois Waterway showing an increase in submersed and emergent aquatic vegetation cover over the two years. Area of interest outlined in yellow. Image centered on 41.420°N, 88.207°W.

In figures 10–12, areas of observed vegetation change are primarily adjacent and directly exposed to the main navigation channel of the IWW and are focused on areas of emergent aquatic vegetation (EAV) cover. These beds show a definite, positive change in EAV cover with figure 10 showing particularly robust change. Figure 11, while showing some increased EAV cover, also shows expansion of SAV bed cover. Lastly, figure 12 shows both areas of increased and decreased EAV, but the general pattern is towards increased cover. Additionally, figure 12 shows a marked area of EAV decrease where a landowner presumably managed out EAV cover. Although figures 10–12 were affected by the same three factors as figures 4–9, the factors had little to no impact on the ability to detect EAV. Additionally, because the areas of SAV in figure 11 were more protected and in shallower areas than in figures 4–9, the factors had little effect on detection.

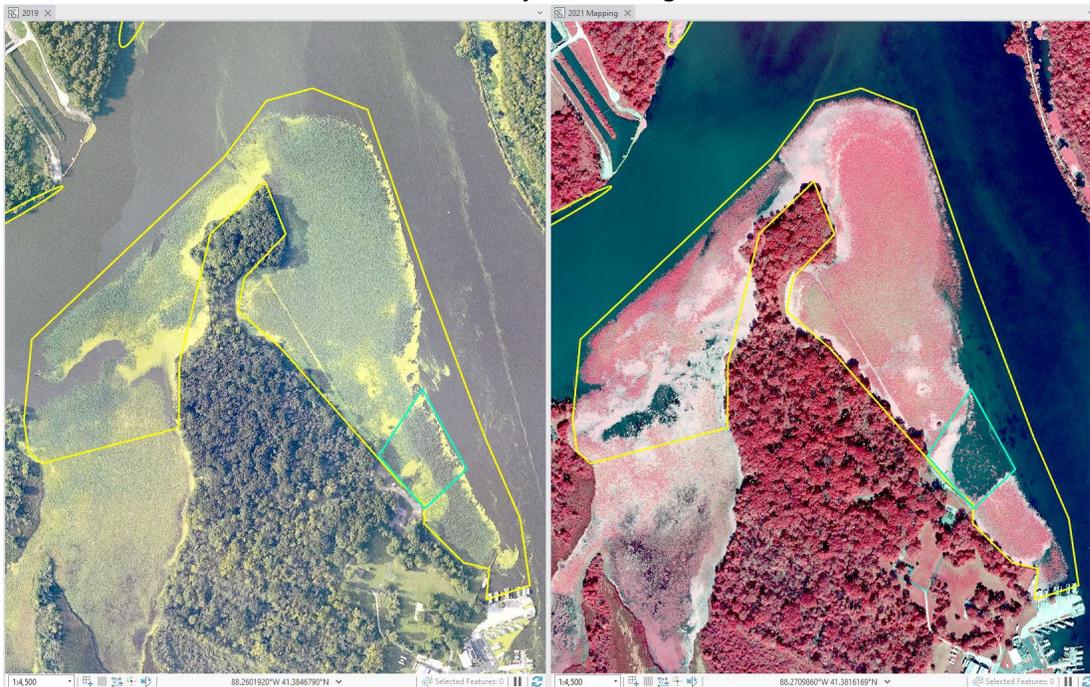
Figure 13. A screen capture comparing the 2019 vegetation (left) to the 2021 vegetation (right) at Delbridge Island in Starved Rock Pool along the main navigation channel of the Illinois Waterway showing increased submersed and emergent aquatic vegetation cover over the two years. Area of interest outlined in yellow. Image centered on 41.316°N, 88.921°W.

In figures 13–17, areas of observed vegetation change are primarily adjacent to the main navigation channel, but also somewhat sheltered from direct wake or seiche effects from boat traffic. This sheltering introduces a confounding variable into interpretation of change in these areas. In all five figures, vegetation development occurred primarily on the more sheltered portions of the sites, although not exclusively. In figure 13, 15, and 17, vegetation development was partially related to decreased water depth and exposed sediments, but also included notable SAV expansion in areas directly facing the canal. In figure 14 and 16, expansion of EAV is very visible with expansion radiating outward from the most sheltered areas to less protected zones.

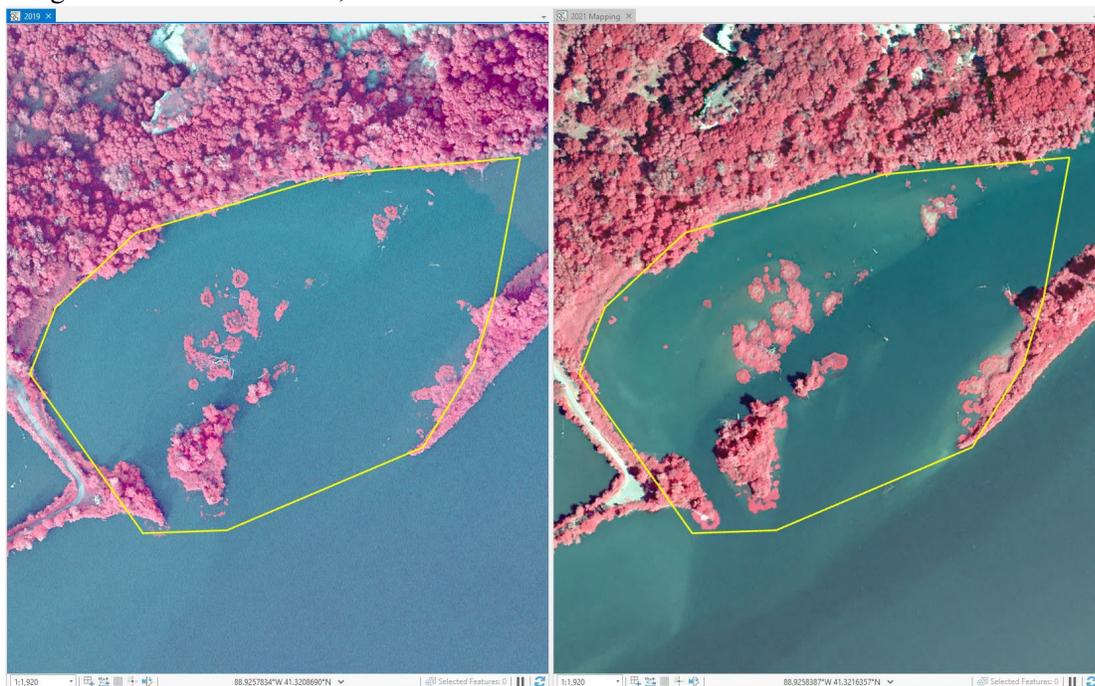
Figure 15. A screen capture comparing the 2019 vegetation (left) to the 2021 vegetation (right) at Delbridge Island in Starved Rock Pool along the main navigation channel of the Illinois Waterway showing increased submersed and emergent aquatic vegetation cover over the two years. Area of interest outlined in yellow. Image centered on 41.314°N, 88.933°W.

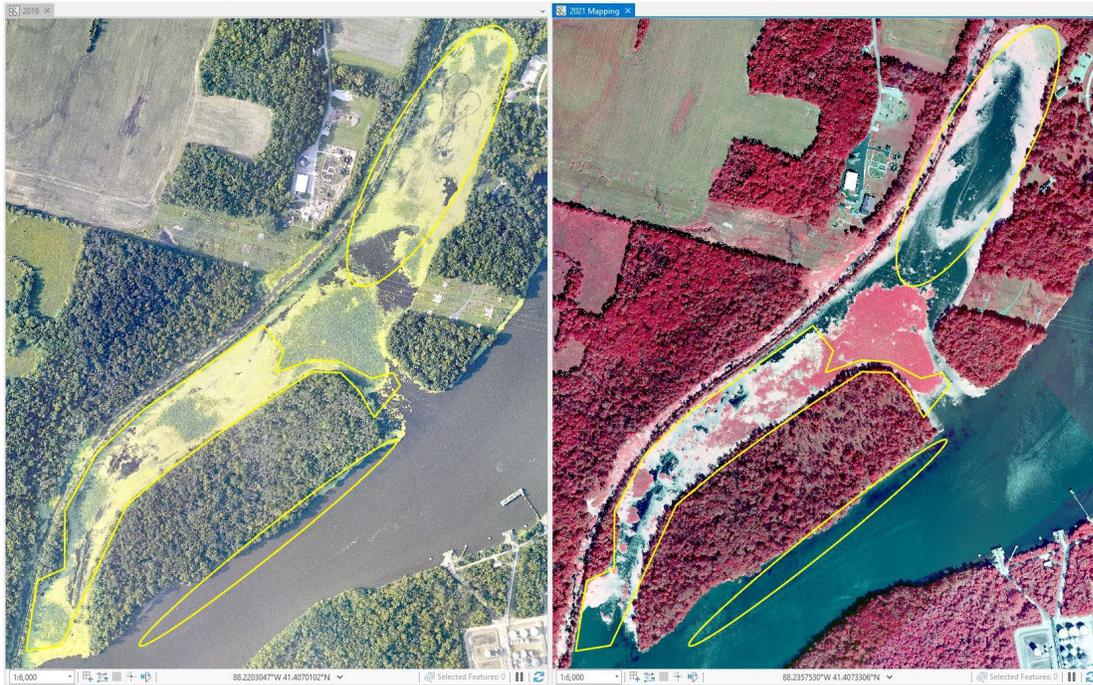
Figure 21. A screen capture comparing the 2019 vegetation (left) to the 2021 vegetation (right) at Clark Island in Marseilles Pool in the side channels of the Illinois Waterway showing increased SAV and EAV cover over the two years. Area of interest outlined in yellow. Image centered on 41.318°N, 88.693°W.

In figure 18–21, these large side channels are directly adjacent to the main navigation channel of the IWW but are mostly or completely isolated from wake or seiche effects. In each of these areas, different directions of change are noted, with some areas showing increases in SAV or EAV and others showing decreases. There does not appear to be a consistent direction or constant pattern of change.

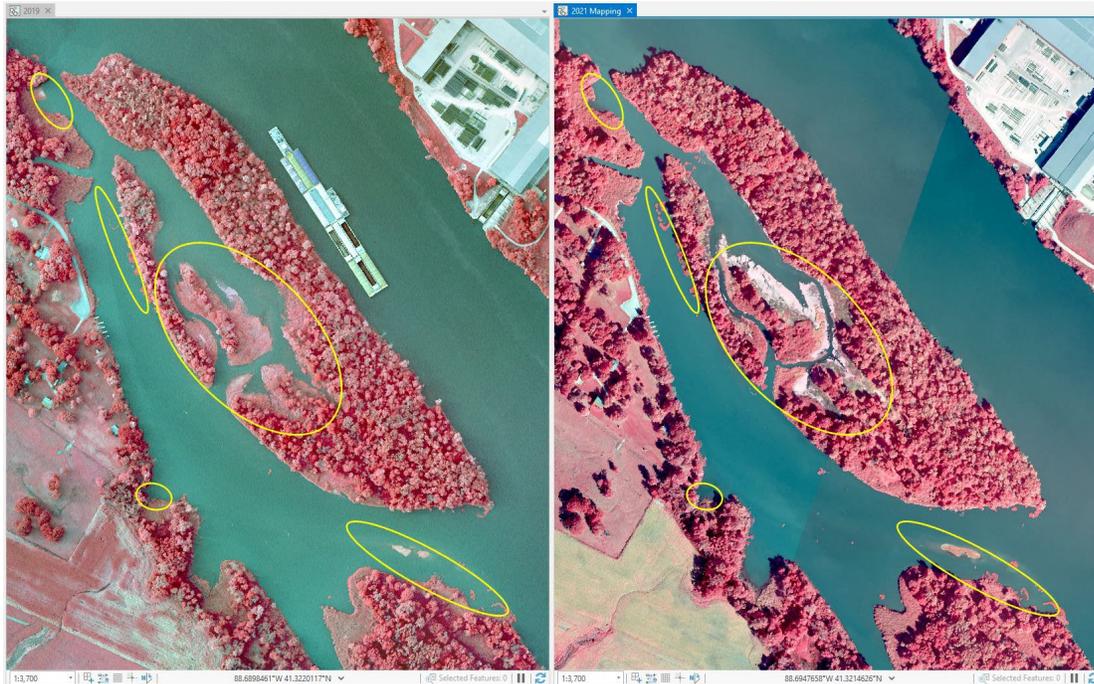
Figure 22. A screen capture comparing the 2019 vegetation (left) to the 2021 vegetation (right) at Moores Island in Starved Rock Pool in the side channels of the Illinois Waterway showing substantial infill and modification over the two years. Area of interest outlined in yellow. Image centered on 41.341°N, 88.795°W.

In figures 22 and 23, substantial infill and modification is evident between 2019 and 2021. This activity resulted in the wholesale conversion from aquatic habitat to non-aquatic habitat. Reasons for this activity were not investigated.

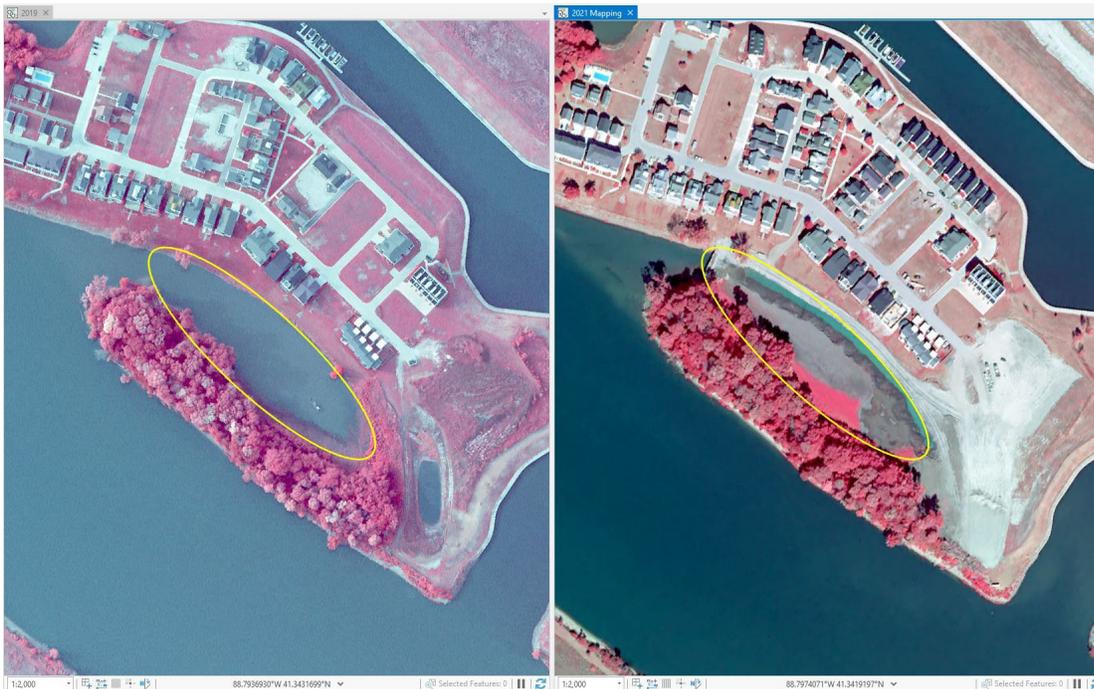
Figure 23. A screen capture comparing the 2019 vegetation (left) to the 2021 vegetation (right) near Huse Lake in Peoria Pool in the side channels of the Illinois Waterway showing substantial infill and modification over the two years. Area of interest outlined in yellow. Image centered on 41.325°N, 89.102°W.

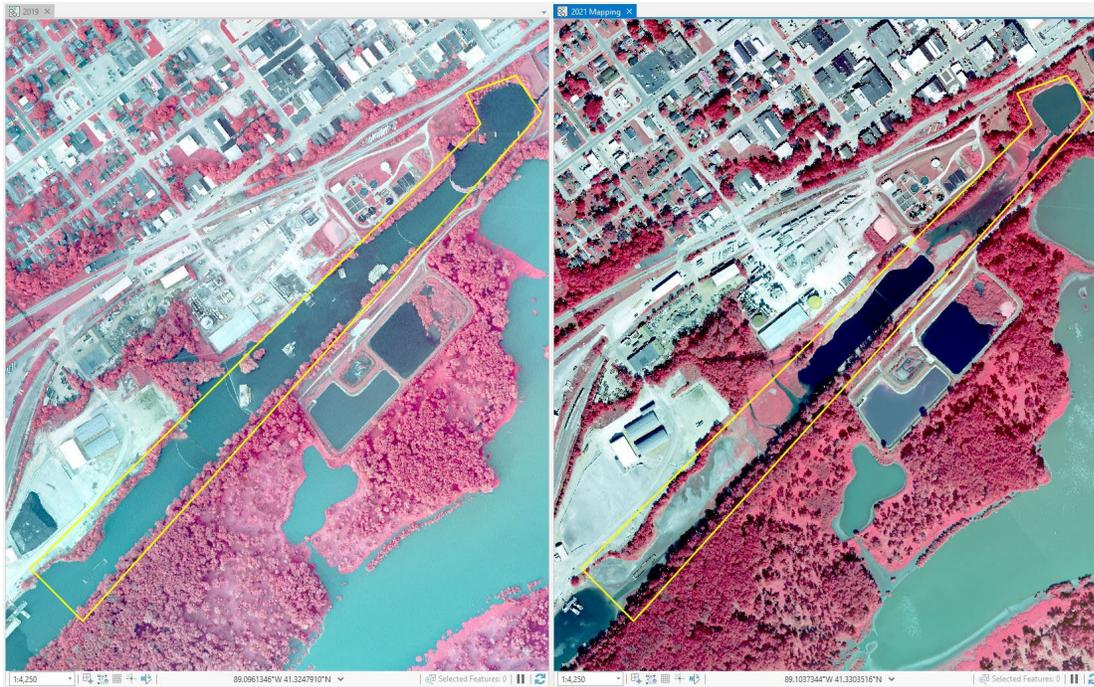
Figure 24. A screen capture comparing the 2019 vegetation (left) to the 2021 vegetation (right) in northern Depue Lake in Peoria Pool in the side channels of the Illinois Waterway showing increased EAV cover over the two years. Area of interest outlined in yellow. Image centered on 41.321°N, 89.297°W.

In figures 24–29, 31–32, 34–47, 49–51, and 55–56 water level decreased over the two years, creating large areas of shallow water and exposing sediment to aquatic vegetation colonization. In these areas, substantial increases in SAV and EAV are evident.

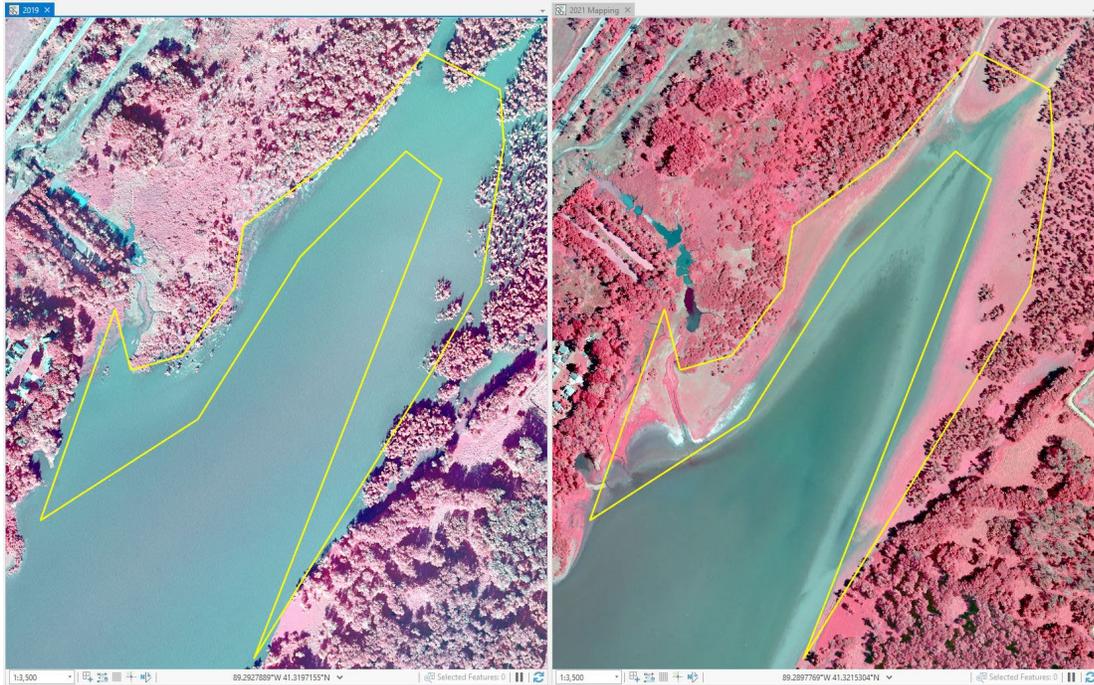
Figure 25. A screen capture comparing the 2019 vegetation (left) to the 2021 vegetation (right) in southern Depue Lake in Peoria Pool in the side channels of the Illinois Waterway showing increased EAV cover over the two years. Area of interest outlined in yellow. Image centered on 41.312°N, 89.322°W.

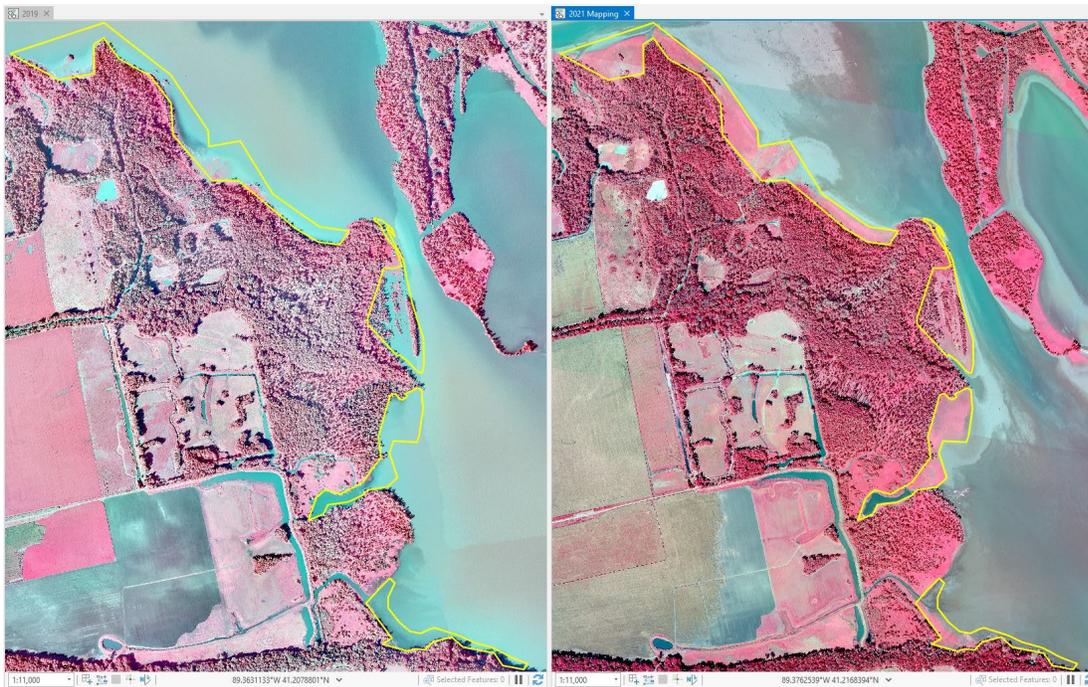
Figure 29. A screen capture comparing the 2019 vegetation (left) to the 2021 vegetation (right) at Dixon Waterfowl Refuge in Peoria Pool in the side channels of the Illinois Waterway showing increased SAV and EAV cover over the two years. Area of interest outlined in yellow. Image centered on 41.214°N, 89.339°W.

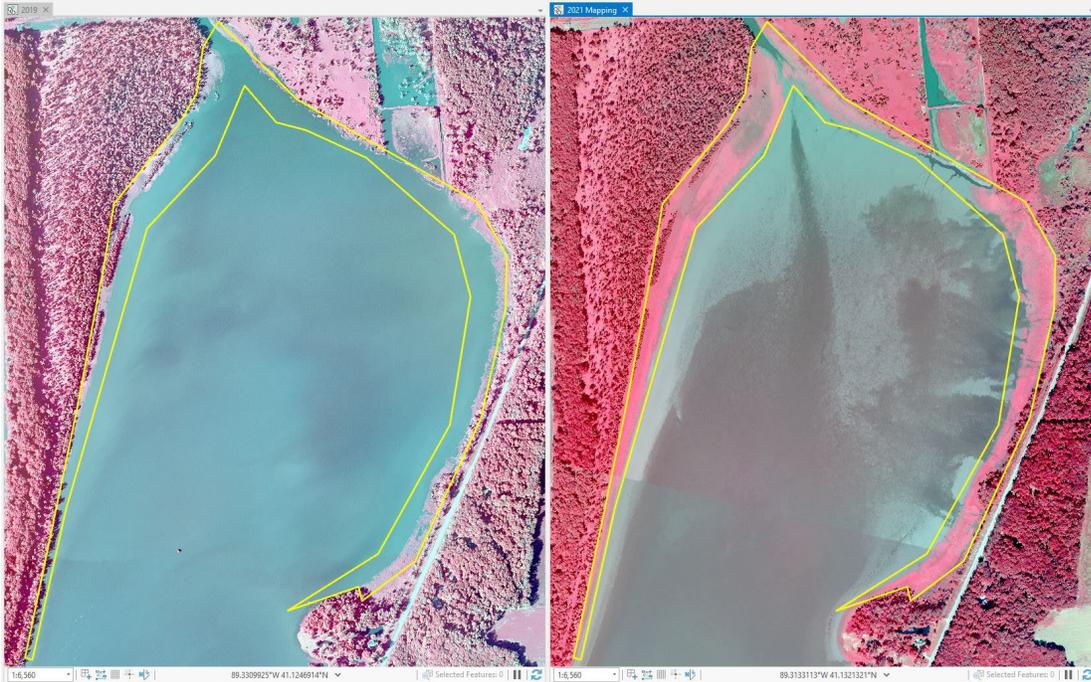
Figure 32. A screen capture comparing the 2019 vegetation (left) to the 2021 vegetation (right) north of Henry Bay in Peoria Pool in the side channels of the Illinois Waterway showing increased EAV cover and exposed sediments over the two years. Area of interest outlined in yellow. Image centered on 41.118°N, 89.342°W.

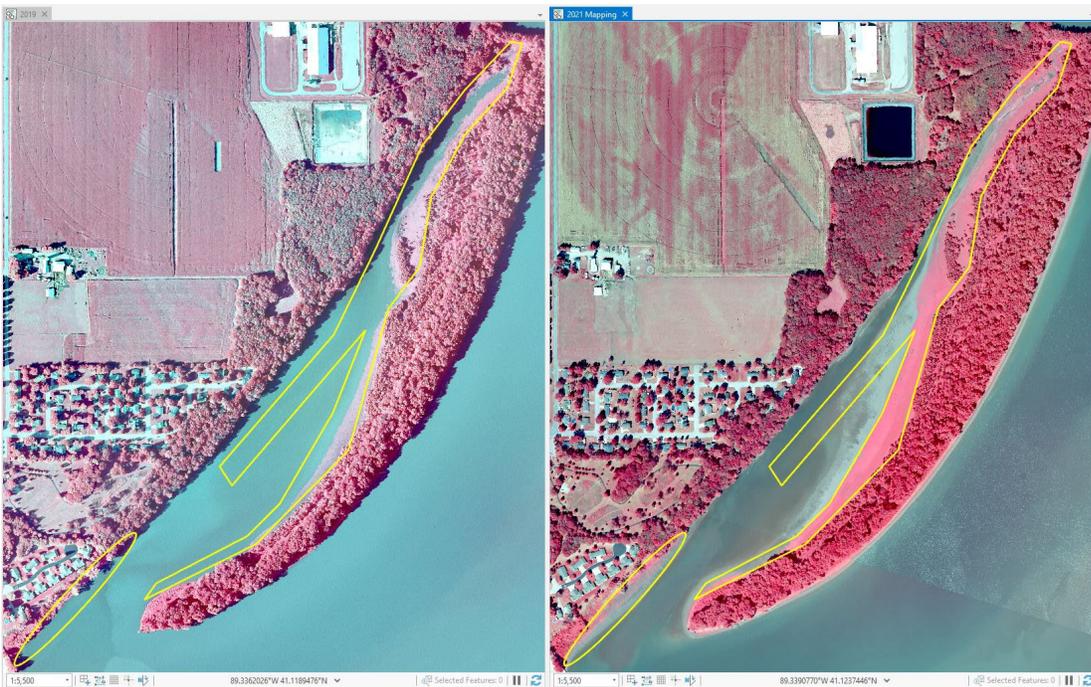
Figure 33. A screen capture comparing the 2019 vegetation (left) to the 2021 vegetation (right) at Whitney Lake in Peoria Lake in the side channels of the Illinois Waterway showing decreased EAV cover and increased exposed sediments in the upper area, increased EAV cover in the middle right area, and increased SAV cover in the lower left area over the two years. Area of interest outlined in yellow. Image centered on 41.102°N, 89.363°W.

In figure 33, three different areas are visible. On the left and middle right of the figure are areas with direct hydrologic influence from the IWW following the general pattern of decreased water levels leading to increased SAV and EAV. On the top of the figure is an area with indirect hydrologic influence from the IWW where water levels and landscapes were managed causing a substantial decrease in both SAV and EAV.

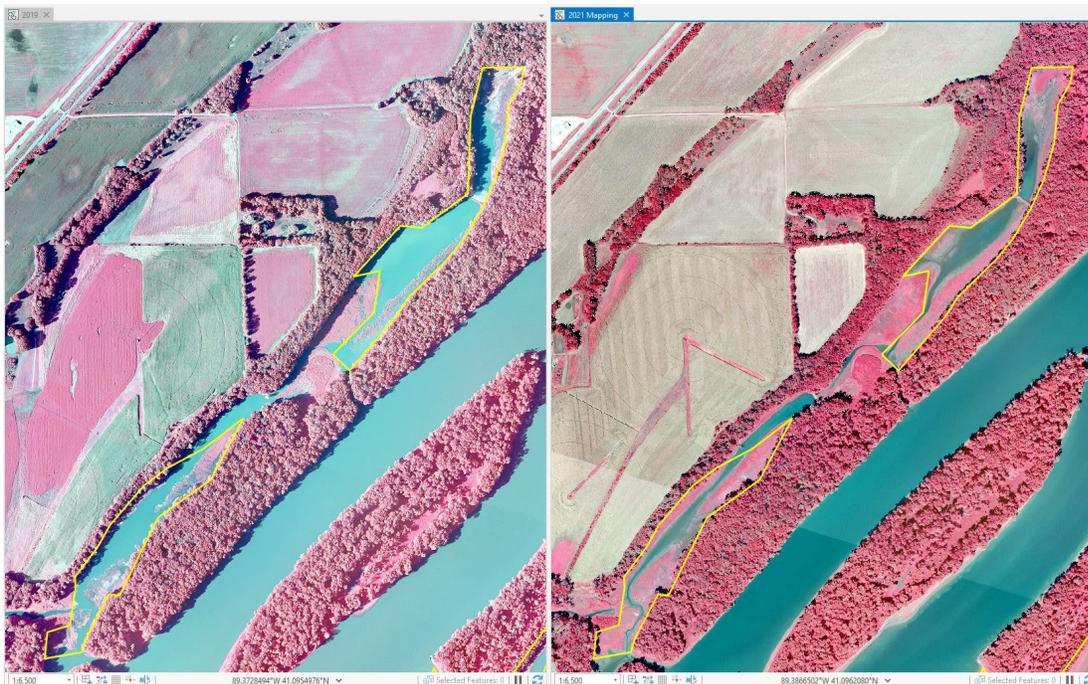
Figure 35. A screen capture comparing the 2019 vegetation (left) to the 2021 vegetation (right) in northern Billsbach Lake in Peoria Pool in the side channels of the Illinois Waterway showing increased EAV cover and exposed sediments over the two years. Area of interest outlined in yellow. Image centered on 41.088°N, 89.357°W.

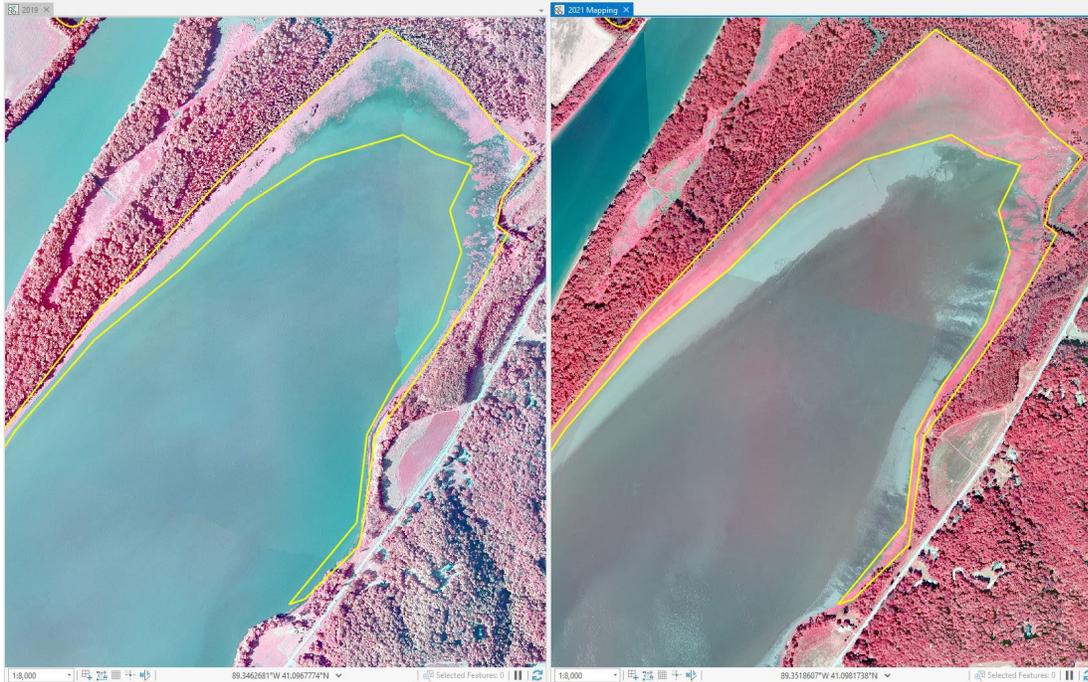
Figure 36. A screen capture comparing the 2019 vegetation (left) to the 2021 vegetation (right) in southern Billsbach Lake in Peoria Pool in the side channels of the Illinois Waterway showing increased EAV cover and exposed sediments over the two years. Area of interest outlined in yellow. Image centered on 41.082°N, 89.375°W.

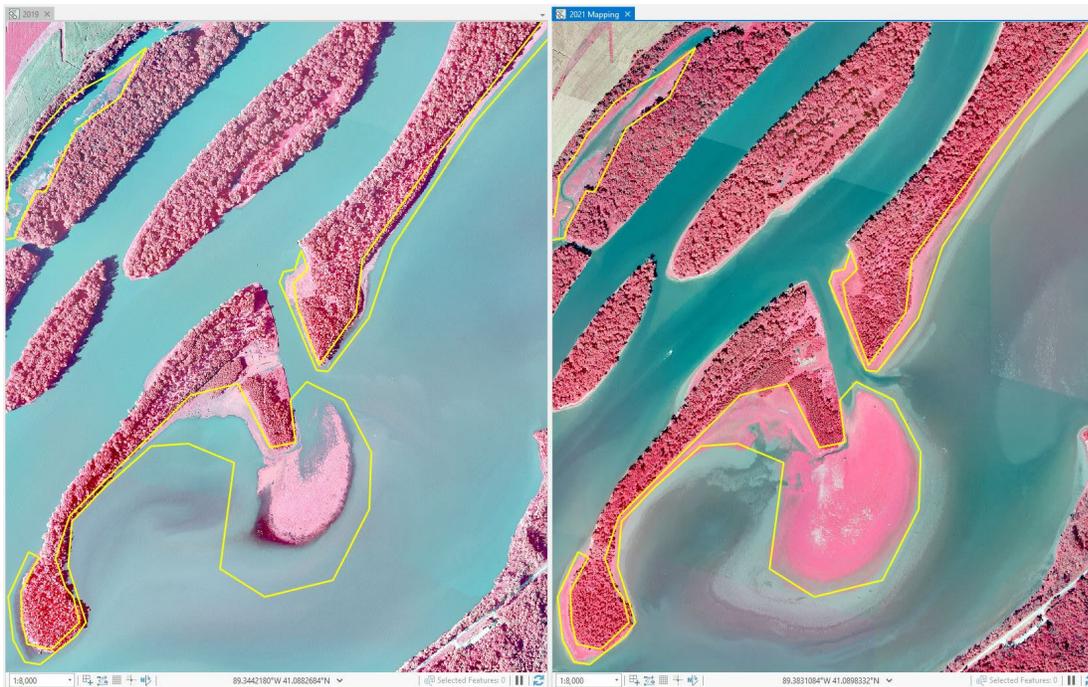
Figure 37. A screen capture comparing the 2019 vegetation (left) to the 2021 vegetation (right) at Weis Lake in Peoria Pool in the side channels of the Illinois Waterway showing increased EAV cover and exposed sediments over the two years. Area of interest outlined in yellow. Image centered on 41.070°N, 89.398°W.

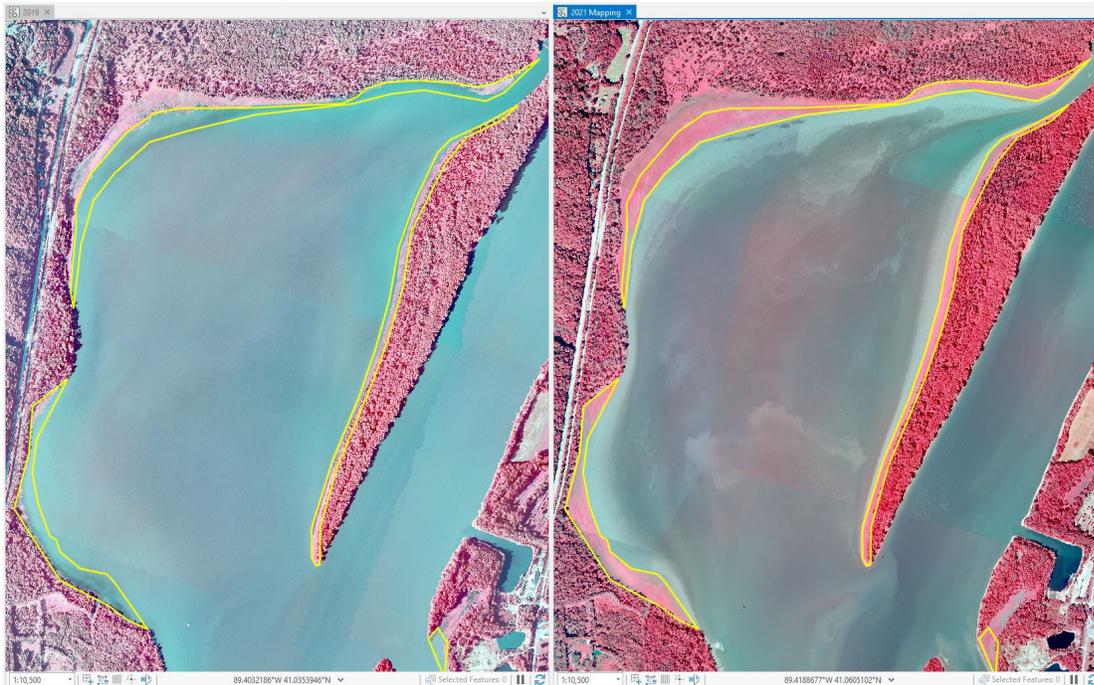
Figure 39. A screen capture comparing the 2019 vegetation (left) to the 2021 vegetation (right) at Lacon Quarry in Peoria Pool in the side channels of the Illinois Waterway showing increased SAV and EAV cover over the two years. Area of interest outlined in yellow. Image centered on 41.058°N, 89.392°W.

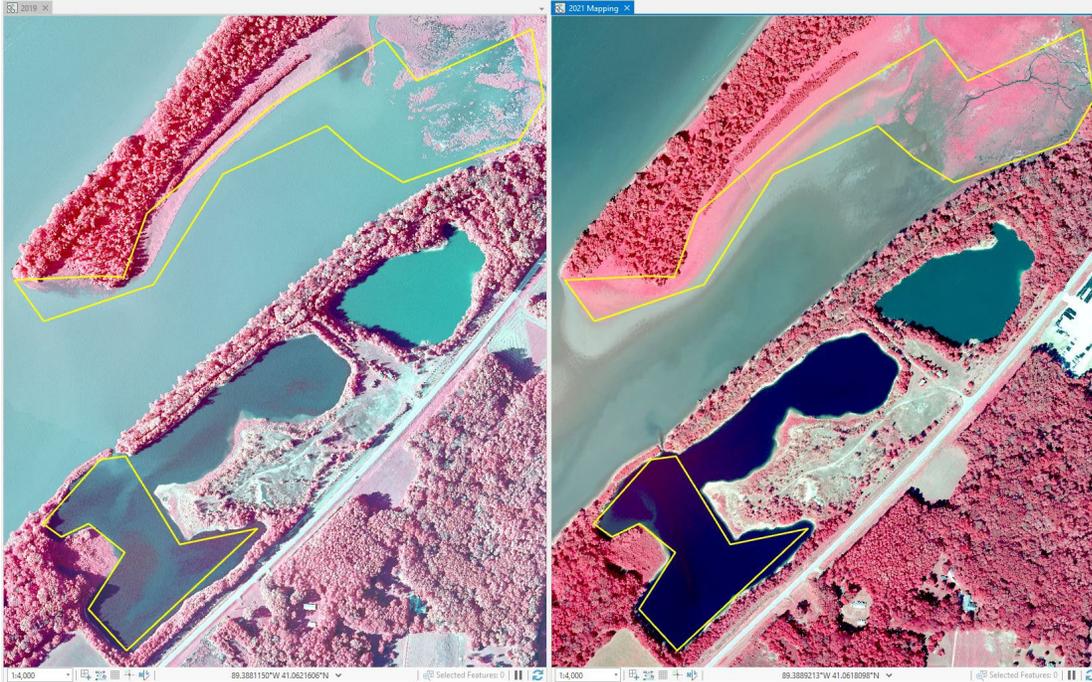
Figure 40. A screen capture comparing the 2019 vegetation (left) to the 2021 vegetation (right) at Wightman Lake in Peoria in the side channels of the Illinois Waterway showing increased EAV cover over the two years. Area of interest outlined in yellow. Image centered on 41.016°N, 89.430°W.

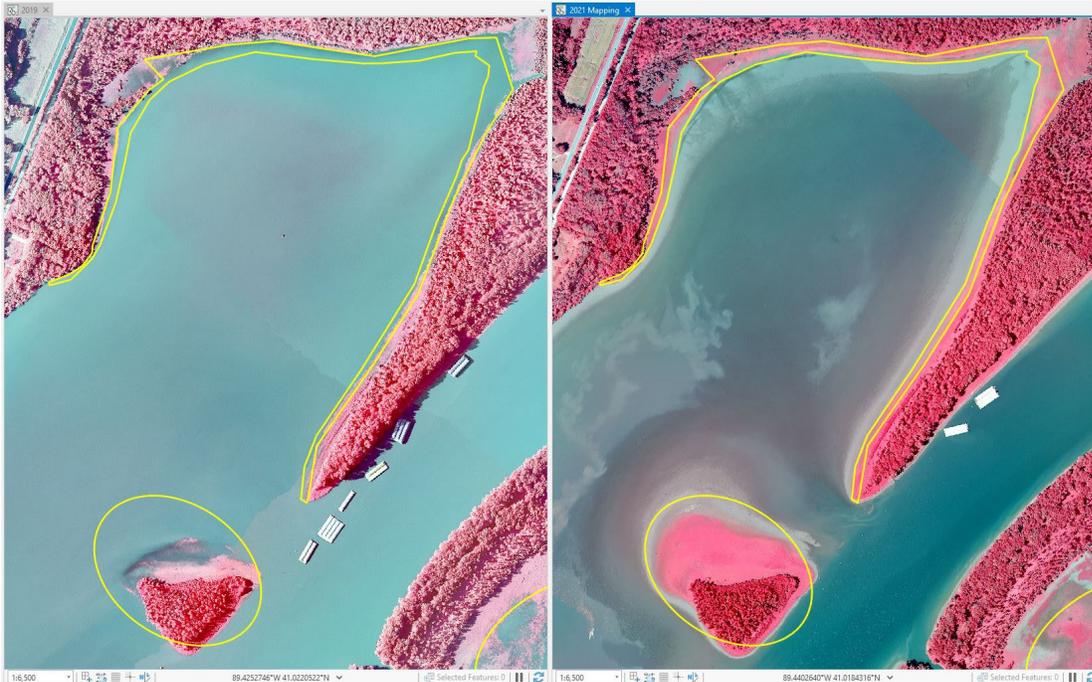
Figure 41. A screen capture comparing the 2019 vegetation (left) to the 2021 vegetation (right) in northern Sawyer Slough in Peoria Pool in the side channels of the Illinois Waterway showing increased EAV cover and exposed sediments over the two years. Area of interest outlined in yellow. Image centered on 41.006°N, 89.419°W.

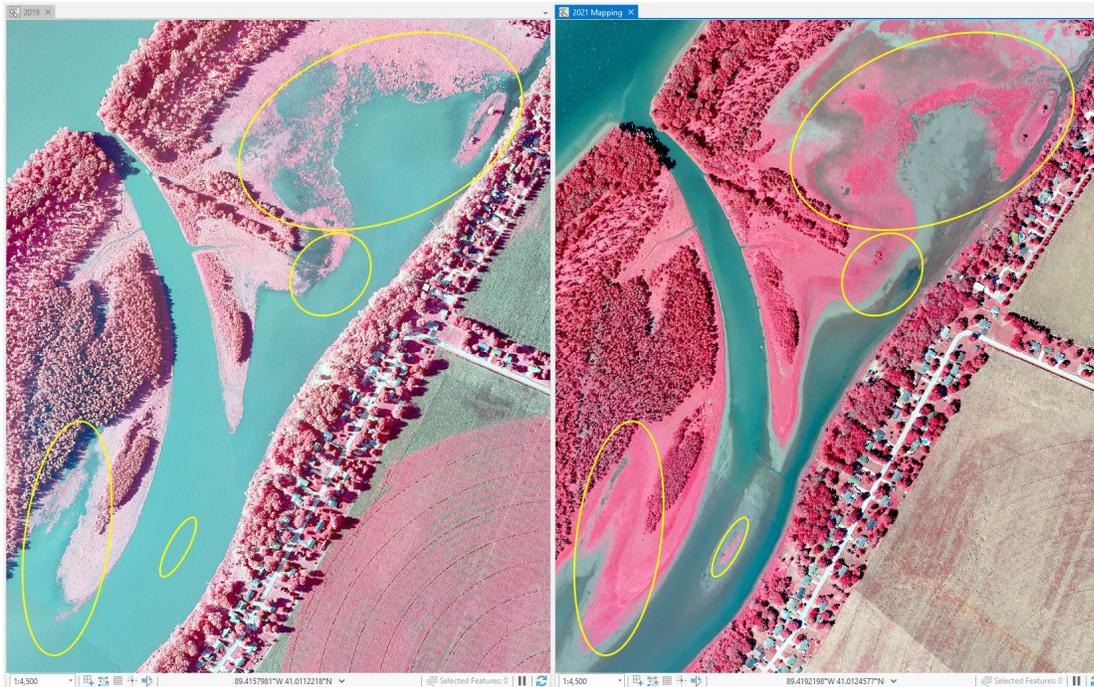
Figure 42. A screen capture comparing the 2019 vegetation (left) to the 2021 vegetation (right) in southern Sawyer Slough in Peoria Pool in the side channels of the Illinois Waterway showing increased EAV cover over the two years. Area of interest outlined in yellow. Image centered on 40.989°N, 89.425°W.

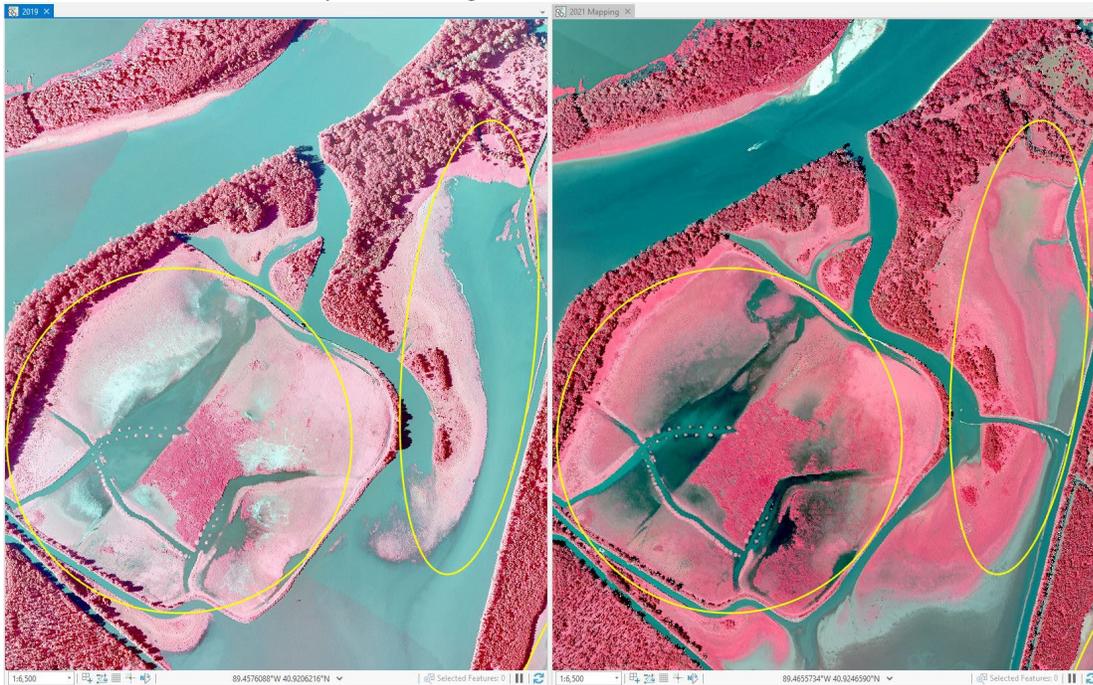
Figure 44. A screen capture comparing the 2019 vegetation (left) to the 2021 vegetation (right) near Chillicothe Island in Peoria Pool in the side channels of the Illinois Waterway showing increased EAV cover over the two years. Area of interest outlined in yellow. Image centered on 40.897°N, 89.482°W.

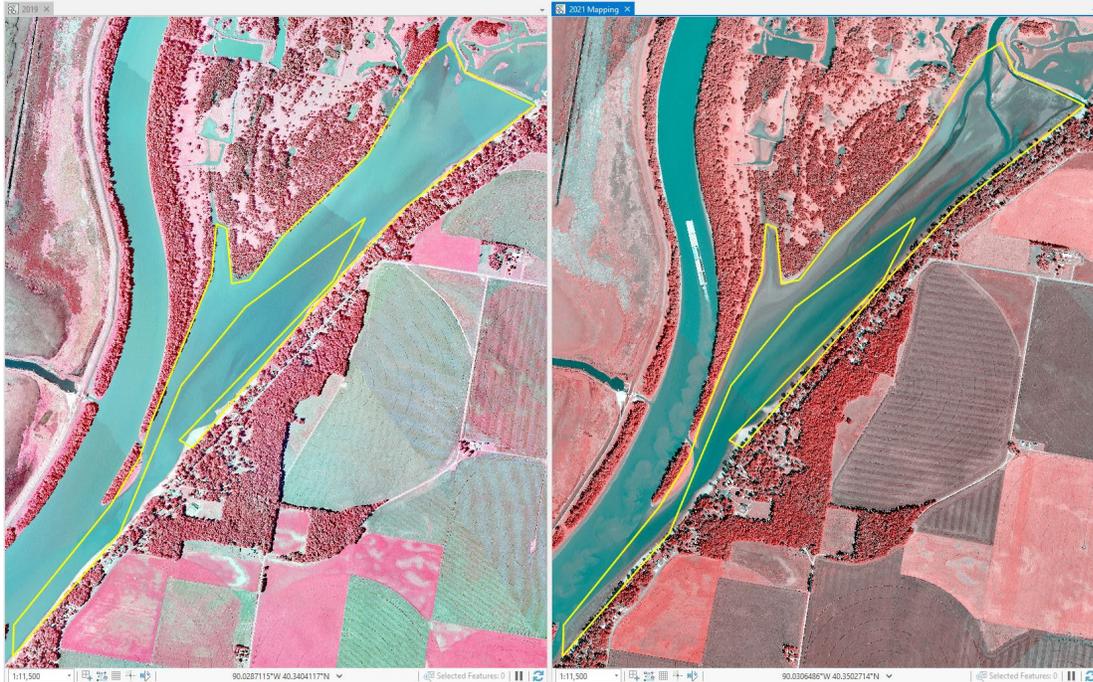
Figure 48. A screen capture comparing the 2019 vegetation (left) to the 2021 vegetation (right) at Bath Lake in La Grange Pool in the side channels of the Illinois Waterway showing a minor decrease in EAV cover in the lower left and a major decrease in EAV in the upper right over the two years. Area of interest outlined in yellow. Image centered on 40.207°N, 90.133°W.

In figure 48, two different areas are visible. On the lower left of the figure is an area with direct hydrologic influence from the IWW following the general pattern of decreased water levels leading to increased SAV and EAV. On the upper right of the figure is an area with indirect hydrologic influence from the IWW where water levels and landscapes were managed causing a substantial decrease in both SAV and EAV.

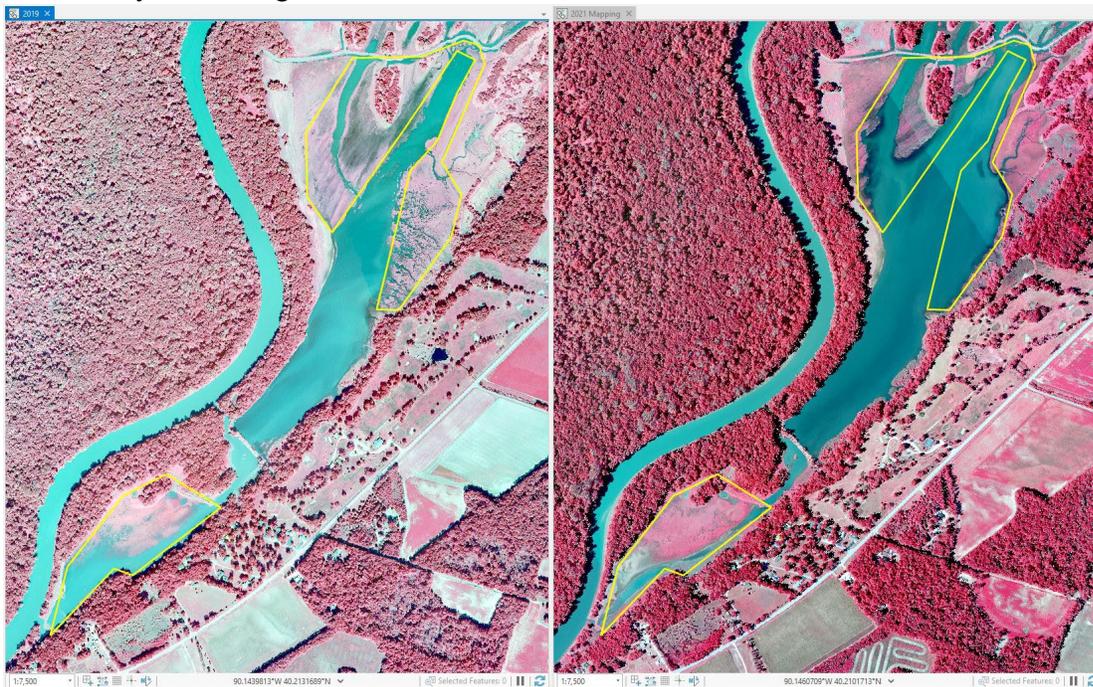
Figure 49. A screen capture comparing the 2019 vegetation (left) to the 2021 vegetation (right) at Grass Lake in La Grange Pool in the side channels of the Illinois Waterway showing increased EAV cover over the two years. Area of interest outlined in yellow. Image centered on 40.205°N, 90.157°W.

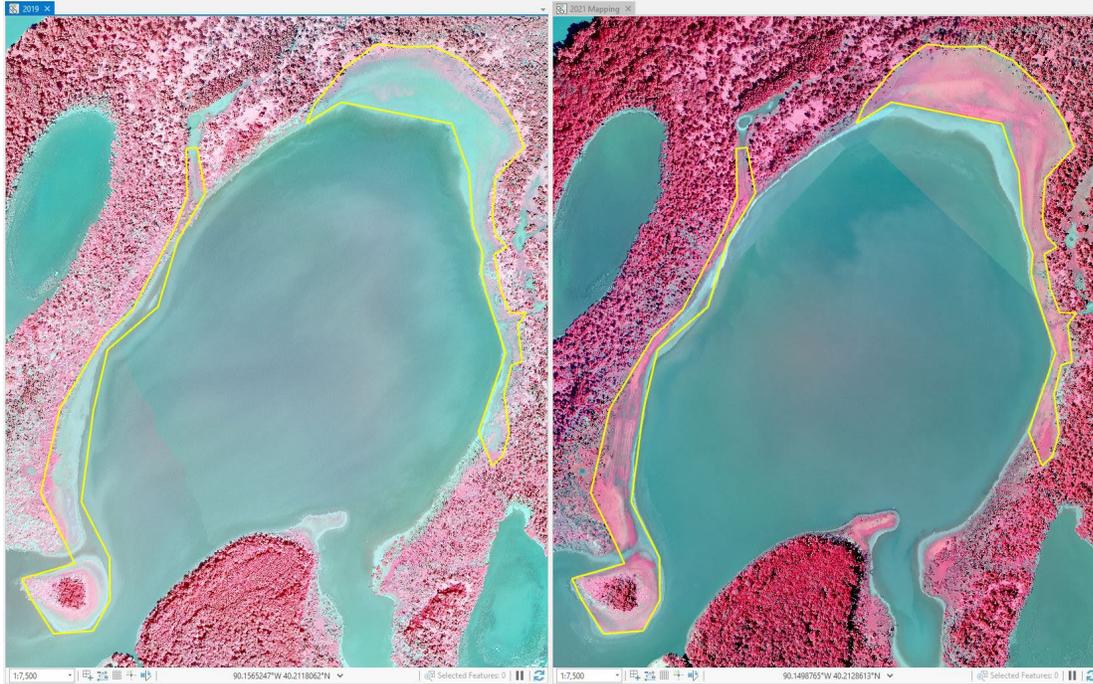
Figure 50. A screen capture comparing the 2019 vegetation (left) to the 2021 vegetation (right) at Moscow Lake in La Grange Pool in the side channels of the Illinois Waterway showing increased SAV cover and decreased EAV cover over the two years. Area of interest outlined in yellow. Image centered on 40.182°N, 90.159°W.

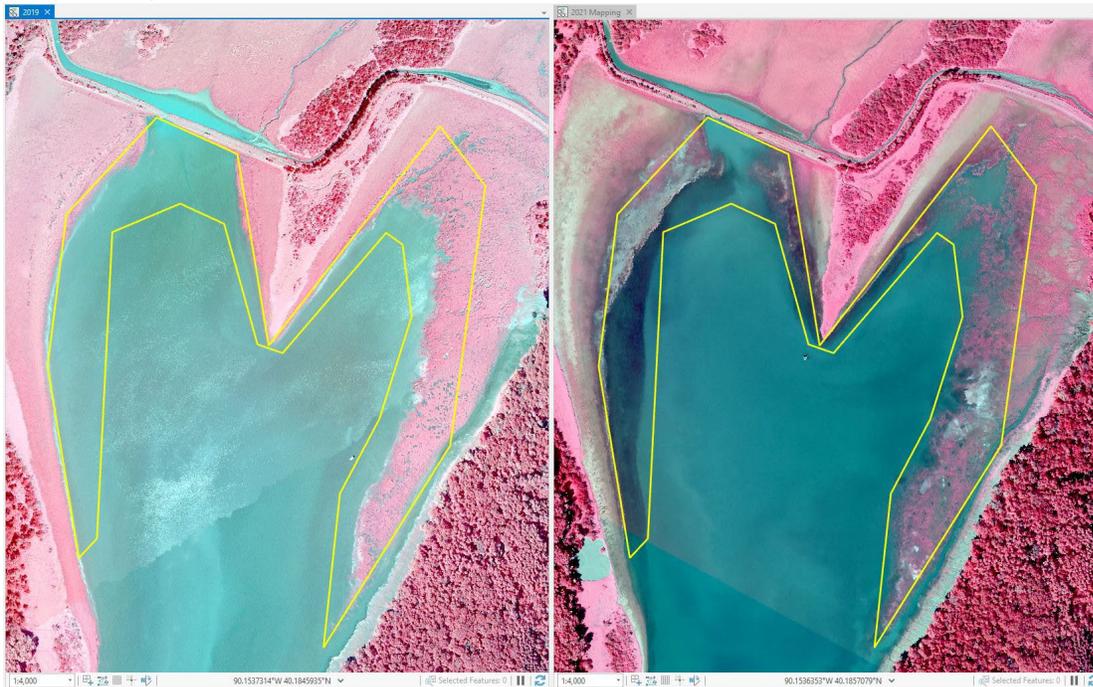
Figure 51. A screen capture comparing the 2019 vegetation (left) to the 2021 vegetation (right) at Jacks Lake in La Grange Pool in the side channels of the Illinois Waterway showing increased EAV cover over the two years. Area of interest outlined in yellow. Image centered on 40.185°N, 90.191°W.
