U.S. Army Corps of Engineers'  
Upper Mississippi River Restoration  
Long Term Resource Monitoring Element

**Completion Report**  
LTRMP-2019AER7

## **Changes in aquatic vegetation cover following lock closure on the Illinois Waterway from 2019 – 2021**

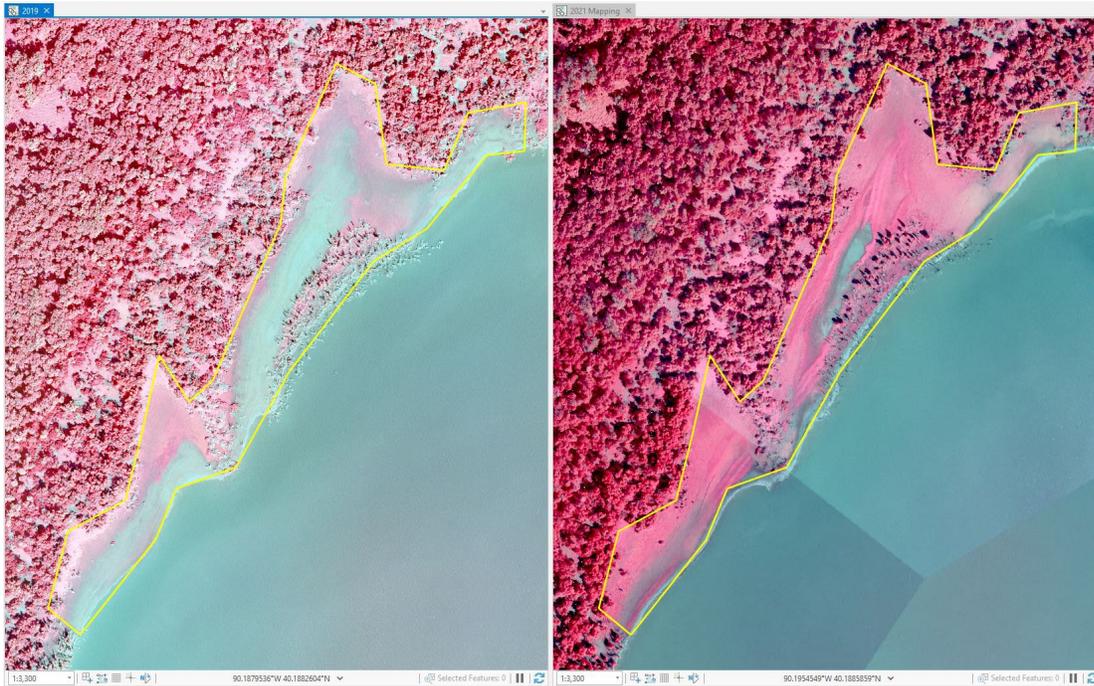
Figure 52. A screen capture comparing the 2019 vegetation (left) to the 2021 vegetation (right) at Chain Lake in La Grange Pool in the side channels of the Illinois Waterway showing increased EAV cover in the left area and decreased EAV cover and exposed sediments in the right area over the two years. Note that the area on the right does not have a direct hydrologic connection to the IWW and may have managed water levels. Area of interest outlined in yellow. Image centered on 40.127°N, 90.320°W.

In figure 52, two different areas are visible. On the left of the figure is an area with direct hydrologic influence from the IWW following the general pattern of decreased water levels leading to increased SAV and EAV. On the right of the figure is an area with indirect hydrologic influence from the IWW where water levels and landscapes were managed causing a substantial decrease in EAV and an increase in SAV.

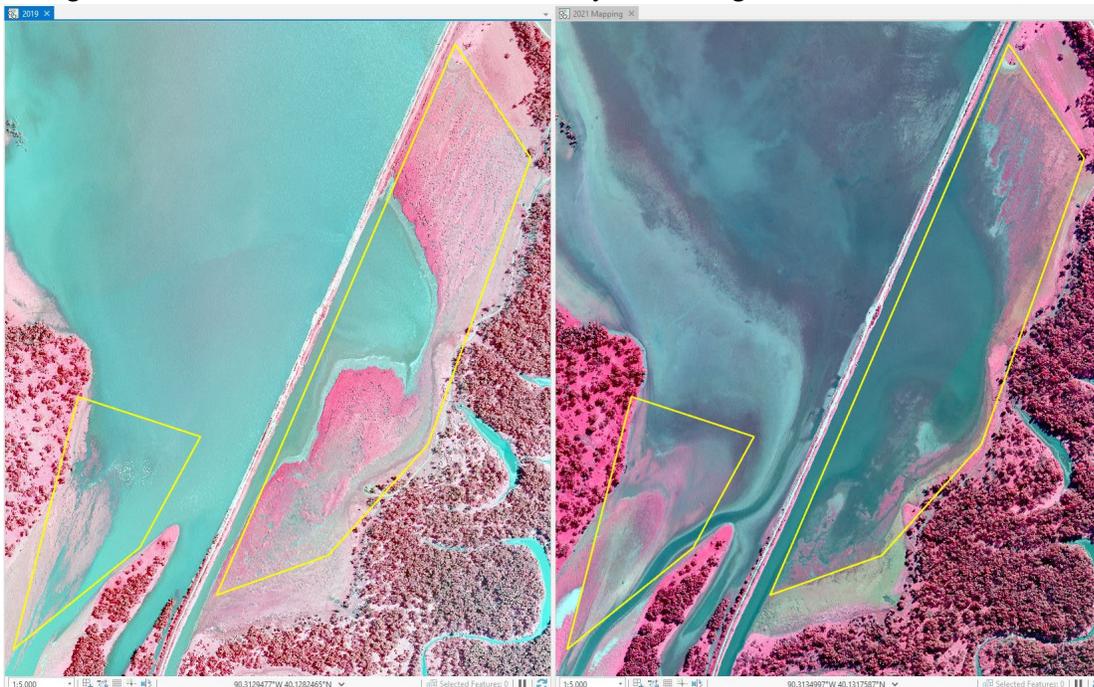
Figure 53. A screen capture comparing the 2019 vegetation (left) to the 2021 vegetation (right) at Sangamon Bay area in La Grange Pool in the side channels of the Illinois Waterway showing increased EAV cover and exposed sediments in the upper left area and decreased EAV cover and exposed sediments in the lower right area over the two years. Area of interest outlined in yellow. Image centered on 40.109°N, 90.378°W.

In figure 53, two different areas are visible. On the upper left of the figure is an area with direct hydrologic influence from the IWW following the general pattern of decreased water levels leading to increased EAV. On the lower right of the figure is an area with indirect hydrologic influence from the IWW where water levels and landscapes were managed causing a substantial decrease in both SAV and EAV.

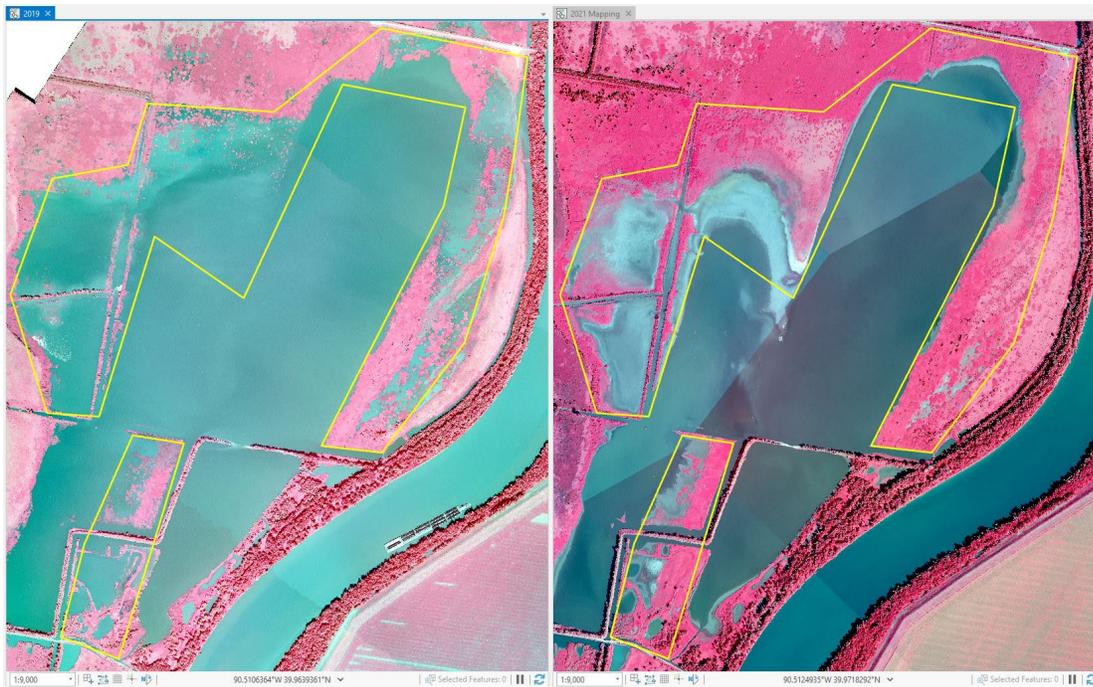
Figure 57. A screen capture comparing the 2019 vegetation (left) to the 2021 vegetation (right) wetlands along Highway 34 in Starved Rock Pool in the side channels of the Illinois Waterway showing decreased EAV cover and increased SAV cover over the two years. Area of interest outlined in yellow. Image centered on 41.327°N, 88.975°W.

In figures 57 and 67–68, these large, hydrologically isolated wetlands appear to have experienced sustained periods of high water. This resulted in a general decrease in the cover of both SAV and EAV over the two-year period.

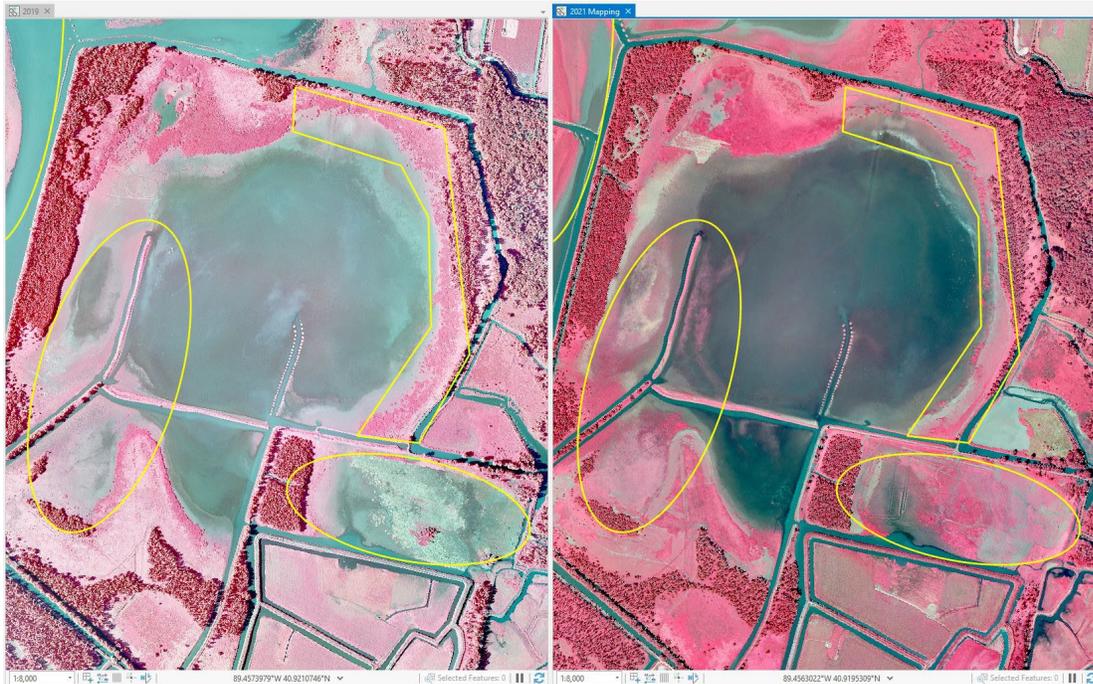
Figure 61. A screen capture comparing the 2019 vegetation (left) to the 2021 vegetation (right) at a pond near North Pekin, Illinois in Peoria Pool in the side channels of the Illinois Waterway showing increased EAV cover and exposed sediments over the two years. Area of interest outlined in yellow. Image centered on 40.626°N, 89.625°W.

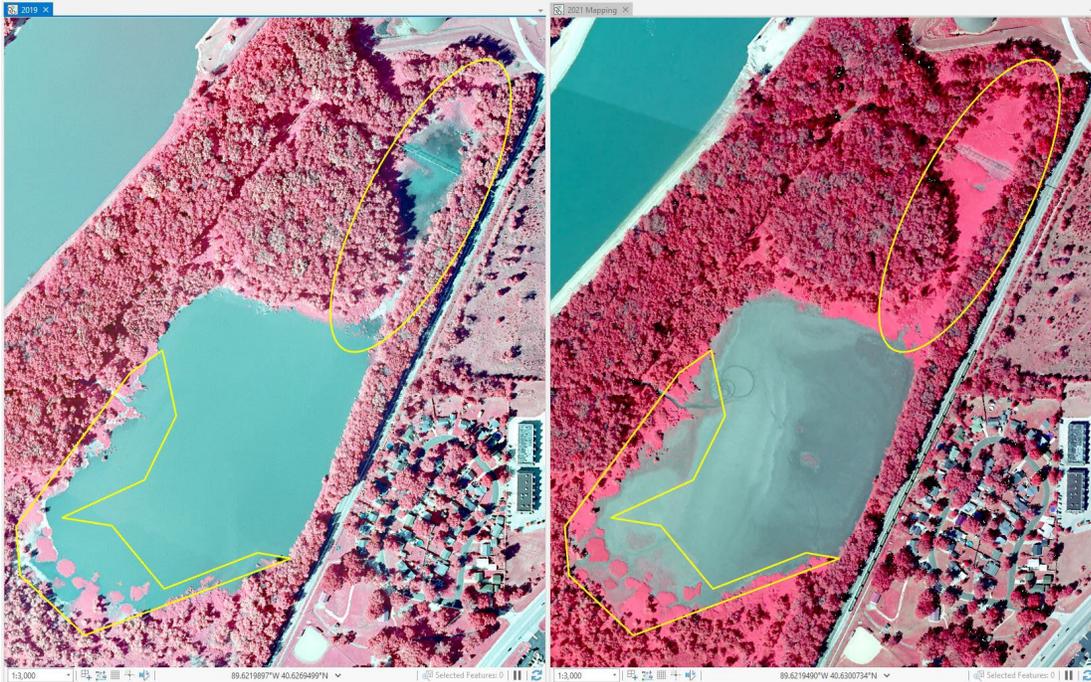
Figure 62. A screen capture comparing the 2019 vegetation (left) to the 2021 vegetation (right) in northern Miserable Lake in La Grange Pool in the side channels of the Illinois Waterway showing increased EAV and SAV cover, and increased exposed sediments over the two years. Area of interest outlined in yellow. Image centered on 40.485°N, 89.921°W.

In figures 60, 62–66, and 69, these large, hydrologically isolated wetlands appear to have experienced substantial and persistent drying over the two-year period, but because of their large size this resulted in a generalized increase in available habitat for both SAV and EAV. This resulted in a general increase in both SAV and EAV cover in these wetlands.

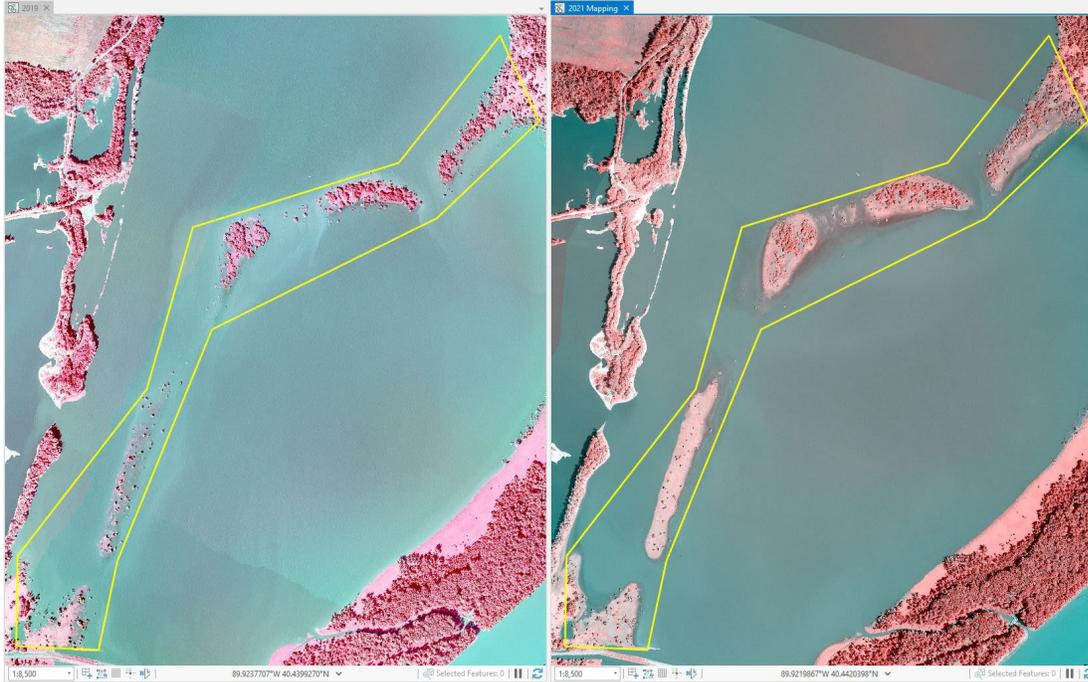
Figure 66. A screen capture comparing the 2019 vegetation (left) to the 2021 vegetation (right) at the northern end of Quiver Lake in La Grange Pool in the side channels of the Illinois Waterway showing increased EAV cover over the two years. Area of interest outlined in yellow. Image centered on 40.415°N, 89.926°W.

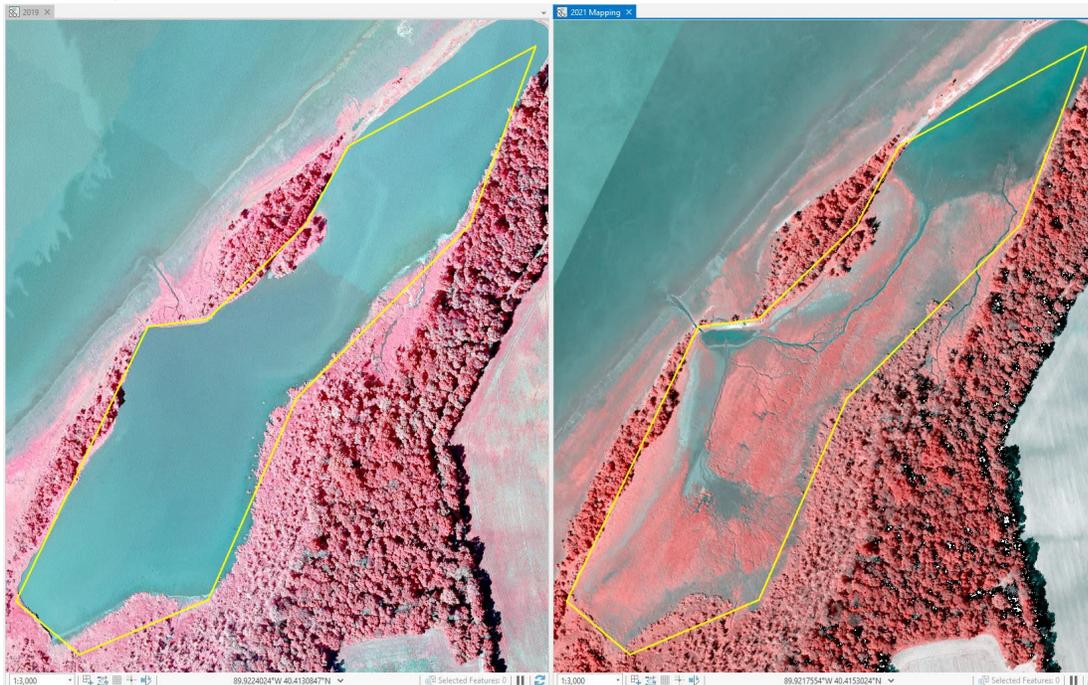
Figure 67. A screen capture comparing the 2019 vegetation (left) to the 2021 vegetation (right) at the southern end of Quiver Lake and northern end of Chautauqua Lake in La Grange in the side channels of the Illinois Waterway showing conversion of EAV to bare sediment in the lower area and a large decrease in EAV cover in the upper area over the two years. Area of interest outlined in yellow. Image centered on 40.388°N, 89.975°W.

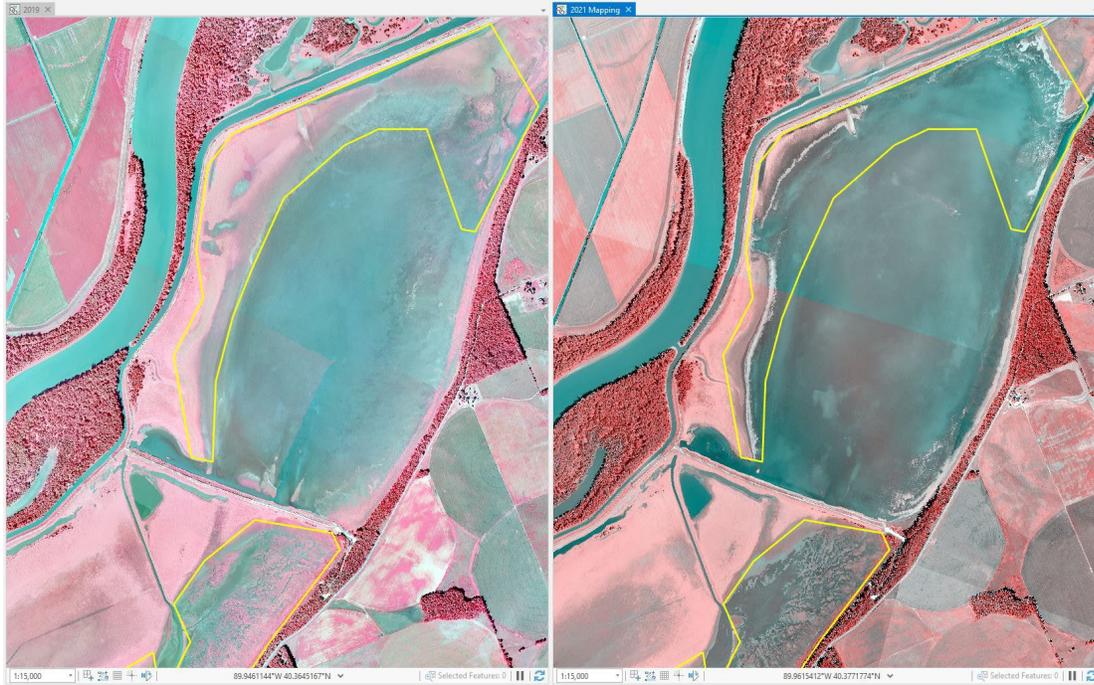
Figure 68. A screen capture comparing the 2019 vegetation (left) to the 2021 vegetation (right) at Chautauqua Lake in La Grange Pool in the side channels of the Illinois Waterway showing a large conversion of EAV to SAV cover over the two years. Area of interest outlined in yellow. Image centered on 40.364°N, 90.018°W.
